INDEPENDENT ORBITER ASSESSMENT

ANALYSIS OF THE EXTRAVEHICULAR MANEUVERING UNIT

WORKING PAPER NO. 1.0-WP-VA86001-15

INDEPENDENT ORBITER ASSESSMENT
ANALYSIS OF THE EXTRAVEHICULAR MOBILITY UNIT

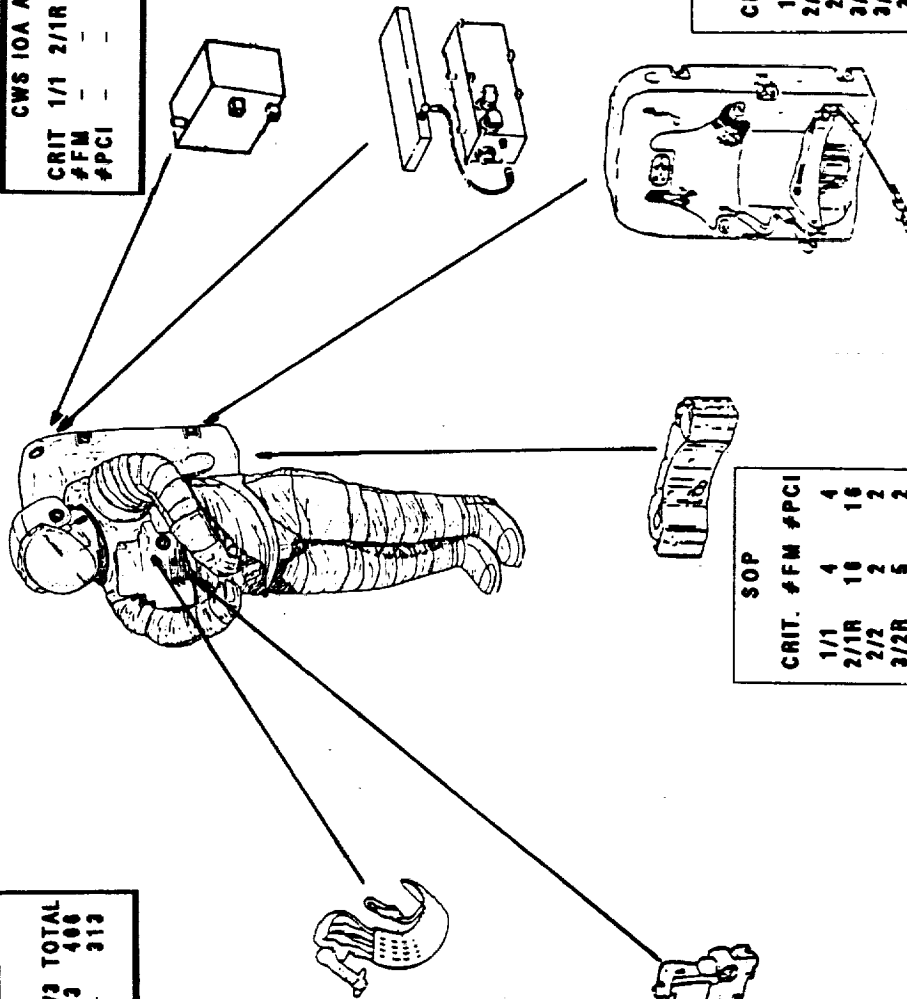
Figure 1 - LSS AND CWS ANALYSIS SUMMARY

PLSS			
CRIT.	#FM	#PCI	
1/1	2	2	
2/1R	135	135	
2/2	28	28	
3/1R	9	9	
3/2R	12	6	
3/3	12	-

CRIT - CRITICALITY
FM - FAILURE MODE
PCI - POTENTIAL CRITICAL ITEM

Figures 1 and 2 present a summary of the failure criticalities for each of the three major subdivisions of the EMU. A summary of the number of failure modes, by criticality, is also presented below with Hardware (HW) criticality first and Functional (F) criticality second.

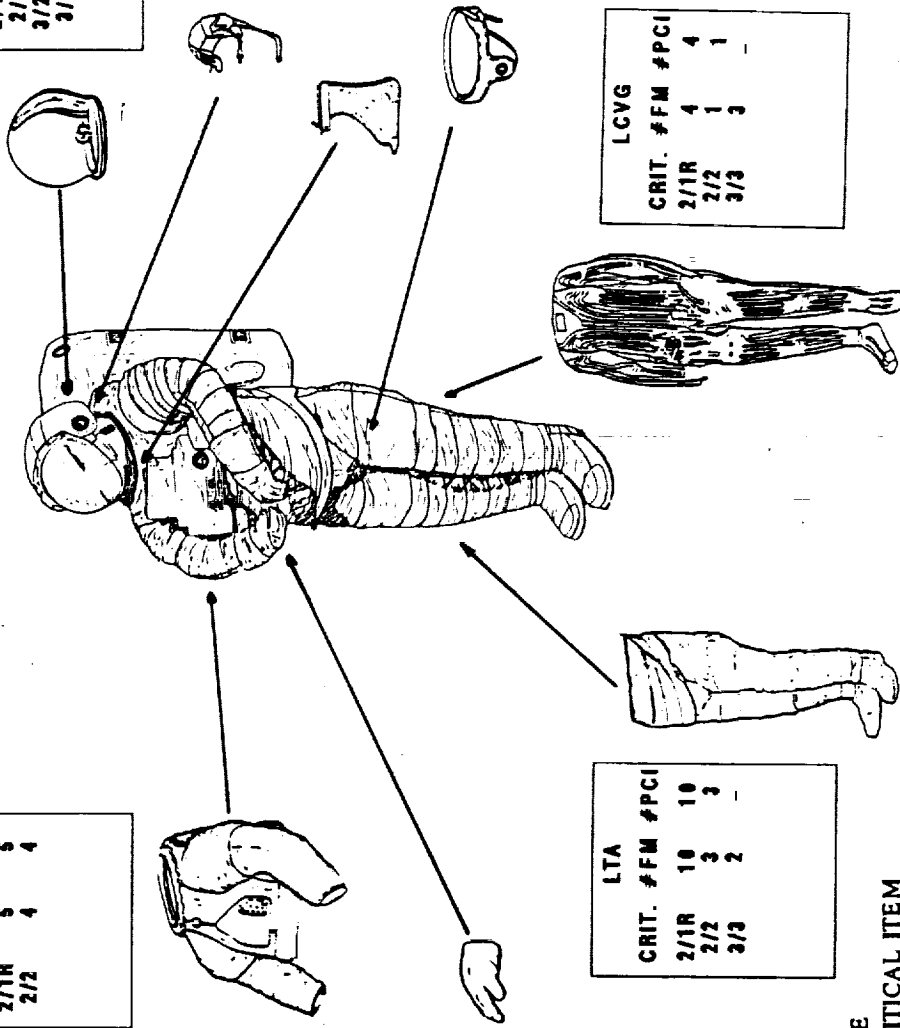
Figure 2 - SSA ANALYSIS SUMMARY

LCVG			
CRIT.	#FM	#PCI	
2/1R	4	4	
2/2	1	1	
3/3	3	-

LTA			
CRIT.	#FM	#PCI	
2/1R	10	10	
2/2	3	3	
3/3	2	-

CRIT - CRITICALITY
 FM - FAILURE MODE
 PCI - POTENTIAL CRITICAL ITEM

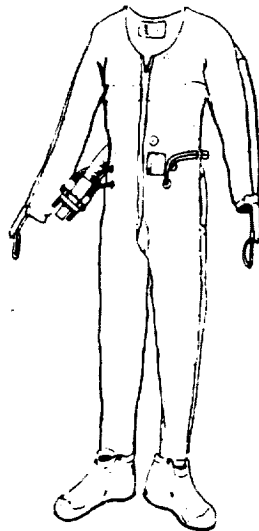
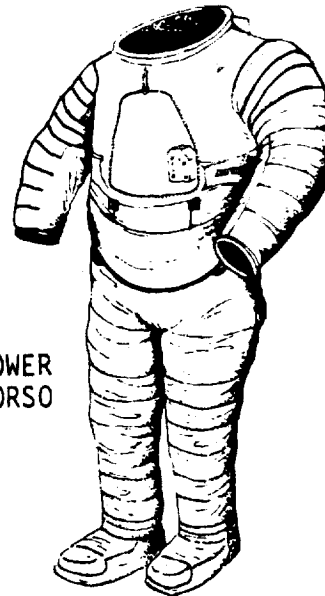
Figure 8 - SSA

LIQUID COOLING
GARMENT

UPPER
TORSO

LOWER
TORSO

2. Space Suit Assembly (SSA) - The SSA, reference Figure 8, provides crewmember enclosure for all EVA operations. Containment of the pressurized environment, ventilation and cooling loop support, crewmember mobility and crewmember visibility are the primary functions provided by the SSA. The assemblies and components comprising the SSA are discussed in the following paragraphs.
